Description:

Model: Pressa idraulica n. 40

Tested lubricant: TAMOIL CARTER EP 100

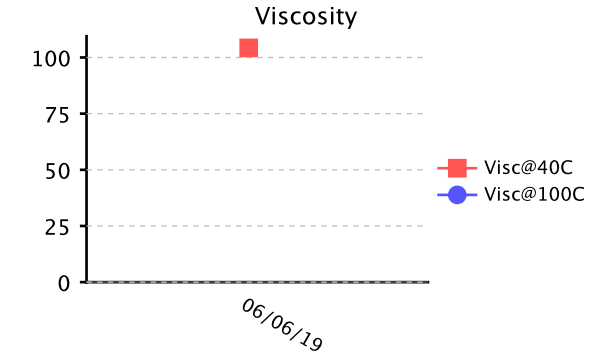
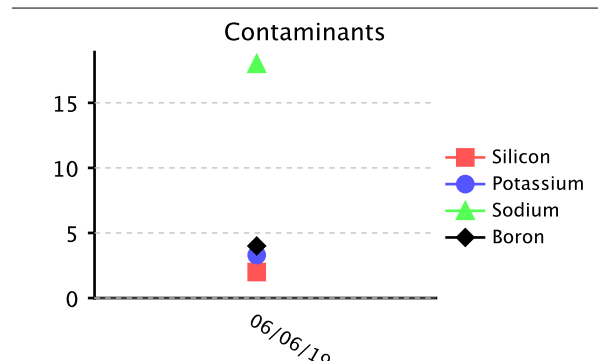
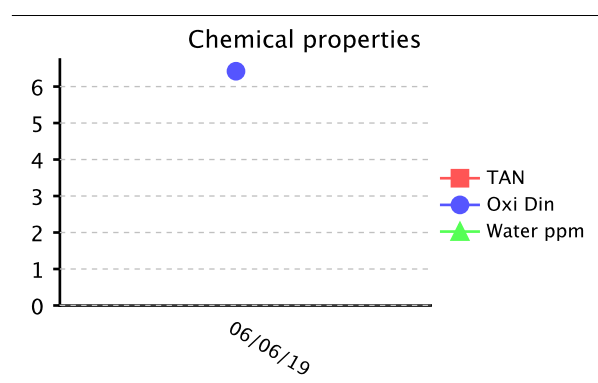
Sample Data & Trends

Sample info	Report status				Alert
	Sample ID				
	Tested lubricant				
	Sampled				06/06/19
	Reported				
	Equipment age				
	Oil age				
	Make-up volume				
	Oil changed				No
	Filter changed				No
Chemical-physical parameter	Appearance				
	Visc@40C ASTM D7042				104,27
	Visc@100C ASTM D7042				
	IV				
	Density API D 15°C				0,891
	TAN (mg KOH/g) ASTM D664				
Part counter	TBN (mg KOH/g) ASTM D2896				
	Water (ppm) ASTM D6304				
	ISO Code 4/6/14 um				21/16/6
	Part. count > 4 um				10423
	Part. count > 6 um				616
	Part. count > 14 um				1
	Nas Code class				8
	2-5 um				326986
	5-15 um				61594
	15-25 um				53
Wear	25-50 um				0
	50-100 um				0
	> 100 um				0
	Sn (Tin)				0
Pb (Lead)				0,1	
Ni (Nickel)				1,1

Il fluido si presenta moderatamente contaminato da particelle di usura, si consiglia di ricampionare a breve per verifica ed eventuale purificazione

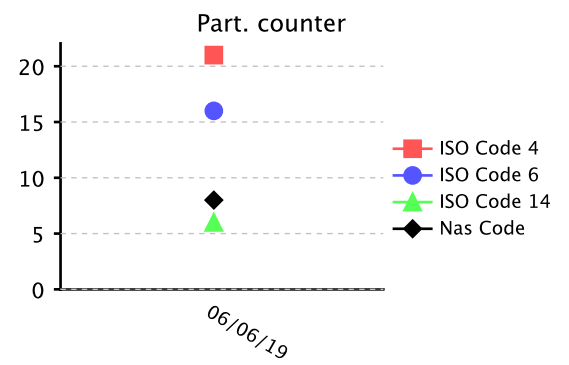
Sample Data & Trends

Wear	Fe (Iron)					8,3
	Cu (Copper)					14,5
	Cr (Chromium)					0,8
	Al (Aluminum)					3,8
	Mn (Manganese)					0
	Ag (Silver)					0
	Ti (Titanium)					0
	Bi (Bismuth)					0
	Co (Cobalt)					0,5
	W (Tungsten)					0
Contaminants	Si (Silicon)					2
	K (Potassium)					3,3
	Na (Sodium)					18
	B (Boron)					4
	V (Vanadium)					0,1
Additive ASTM D6595	Ca (Calcium)					1492,3
	Mg (Magnesium)					26,5
	P (Phosphorus)					641,3
	Zn (Zinc)					788,1
	Ba (Barium)					0
	Mo (Molybdenum)					0,9
FT-IR	Water hydr. (Vol %)					< 0,1
	Oxi Din abs/0,1mm					6,42
	Nitration NOx id					6,44
	Sulfat Ox id					1,9
	Nitration Din id					0
	Antiwear ZnP id					0
	Glycole %					0
	Soot Din %					0
Varnish (index)
